**Subject: Lopez v. City of New York
InSciTech Project No. 7702**

In particular, I will review the mechanism of injury to Mr. Lopez to assess if it is more consistent with his being **pushed** backward over the Crotona Park North railing or his **falling** or **jumping** from it.

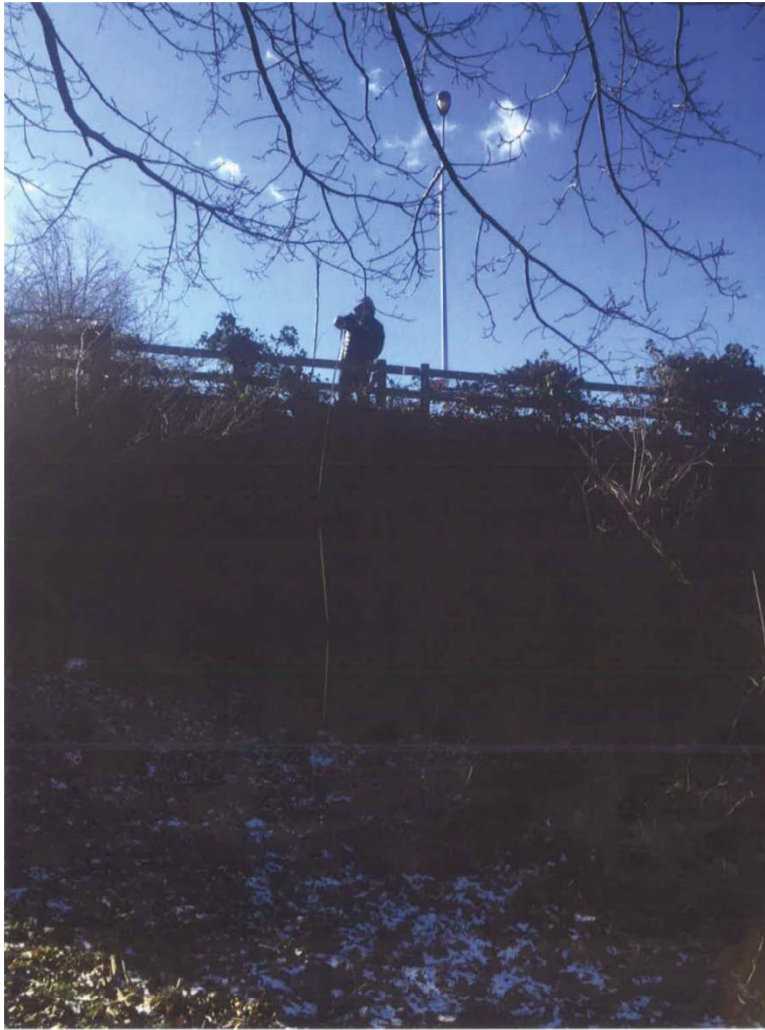
DEF_00254

Figure 3: Photo taken by IAB on January 19, 2016, at 11:15 AM at the location of the incident.

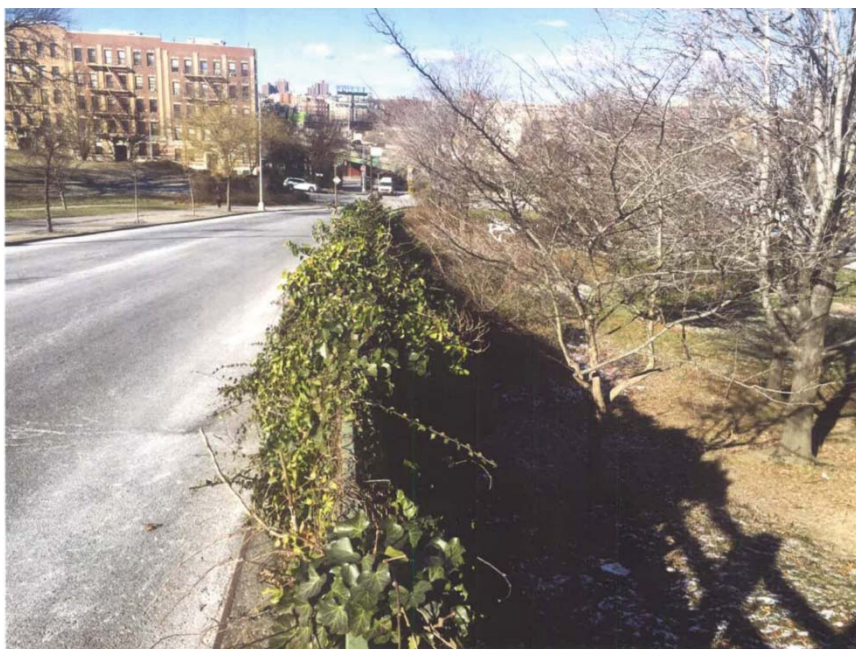
DEF_00259

Figure 4: Photo taken by IAB on January 19, 2016.

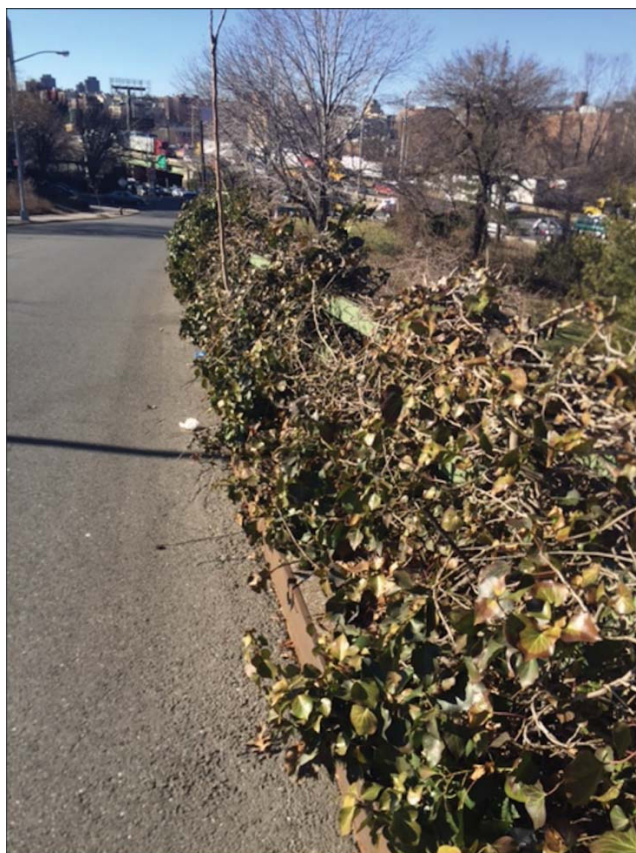
Figure 5: Photo of the incident site taken on February 26, 2016 – two months after the incident.

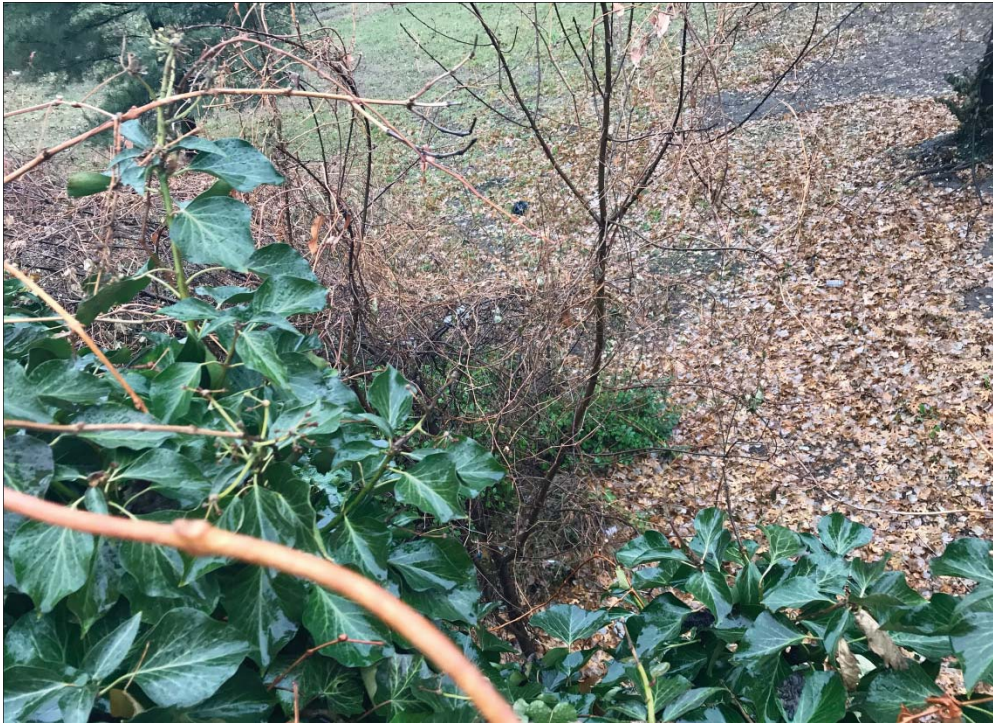
On December 16, 2018, I visited the site of the incident. The following photos show the area described by the officers as the railing that Mr. Lopez fell from. The ivy had grown significantly in the three years since the incident and covered much of the railing. The sidewalk rose 6 inches from the street and the concrete and dirt base extended 18 inches from the fence. The top rail was sturdy and did not move while leaning 175 pounds of body weight against it. The height of the top of the railing was about 36 inches, though 35 inches if measured from the roots and branches of the ivy plants. A plumb line was used to measure the 16 foot distance from the top of the rail to the ground on the other side of the railing from the sidewalk. The vertical wall below the railing was concrete. No steps or shelves were found. The base of the concrete wall met the ivy and leaf covered dirt at 90 degrees.

Figure 10: View looking down from the fence to the ground below. Photos taken December 16, 2018.

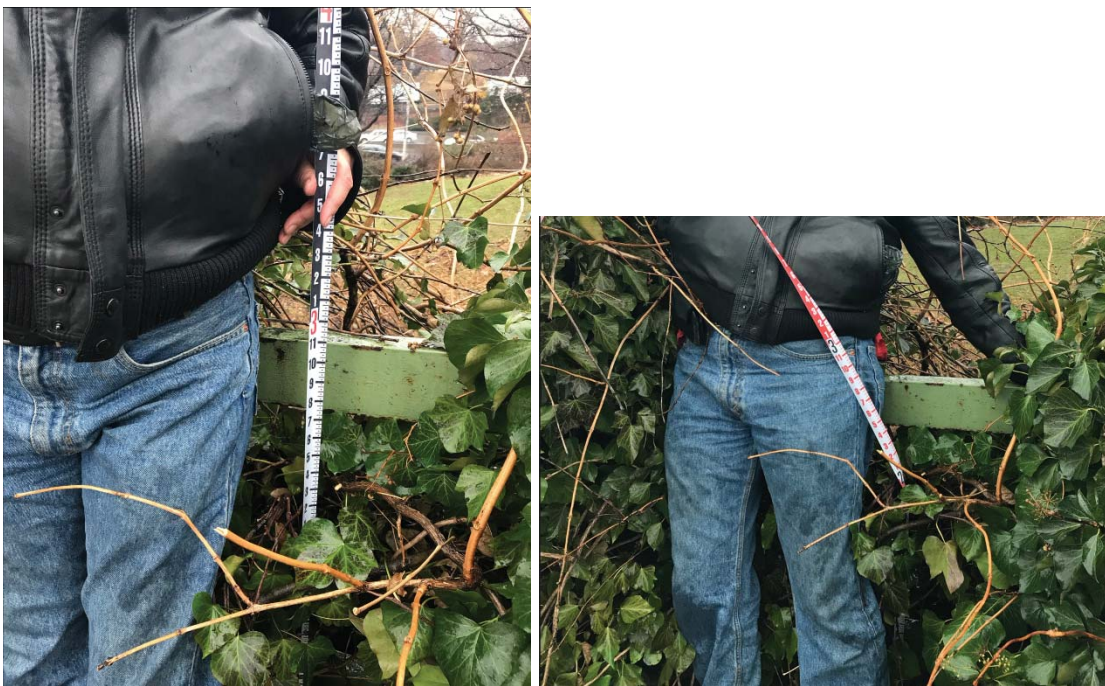
Figure 11: Photos of a 5 ft. 8 in. person standing next to the railing. The waistband is 5 inches above the top rail and the mid buttocks are aligned with the top of the rail.

The center of gravity (C.G.) of an object is defined as the point within an object where the mass of the object balances out, or the point around which the forces of gravity on the body add to zero. The center of gravity of an adult male is estimated to be $0.586 \times$ the height of the individual (Clauser 1969). For a 173 cm. male, this is 101.4 cm. or about 40 inches. Thus, Mr. Lopez' center of gravity was above the top of the railing by at least 5 inches – 40 inches minus 35 inches to the top of the rail while standing on top of foliage. In order for him to be pushed over the top of the fence (as opposed to just being pushed into the fence) the C.G. of his body needed to be higher than the top fence rail. Given his height, his C.G. was already high enough for a push to tip him over the fence. If, as Mr. Lopez describes, Ofc. Linares also lifted him while pushing, the tendency for him to fall would have been even greater. In contrast, if Mr. Lopez' center of gravity were below the level of the fence, it would require lifting him up over the fence in order for him to fall.
